Norroway Pond: Conditions at Grove Street

By: Kevin Lam
Teacher: Diane Brown

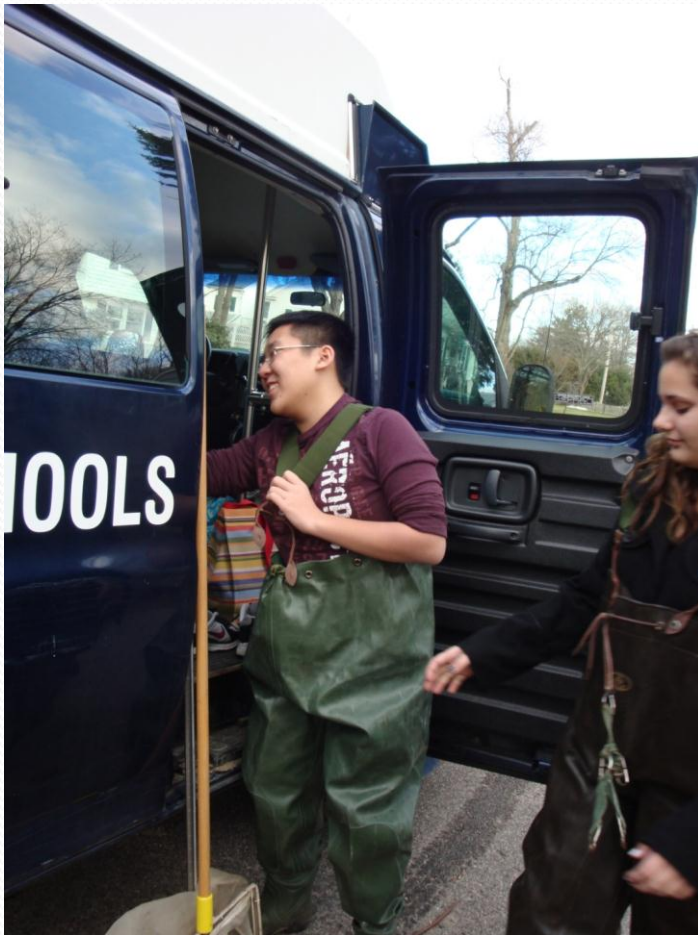
Starting Off

- Water sampling was done in January
- Visited one stream in Randolph, located between Grove Street and West Street
- Goal was to find 200 specimens or more for our research
- Some materials were missing when we went to collect our specimens
- The stream bottom had a great deal of sludge

- Samples may have been lost due to missing the larger container of ethanol to save in
- There was a great deal of sludge in the kick net which was difficult to sift
- Each of the twelve tray sections needed to be sorted to in order to collect 200+ macroinvertebrates

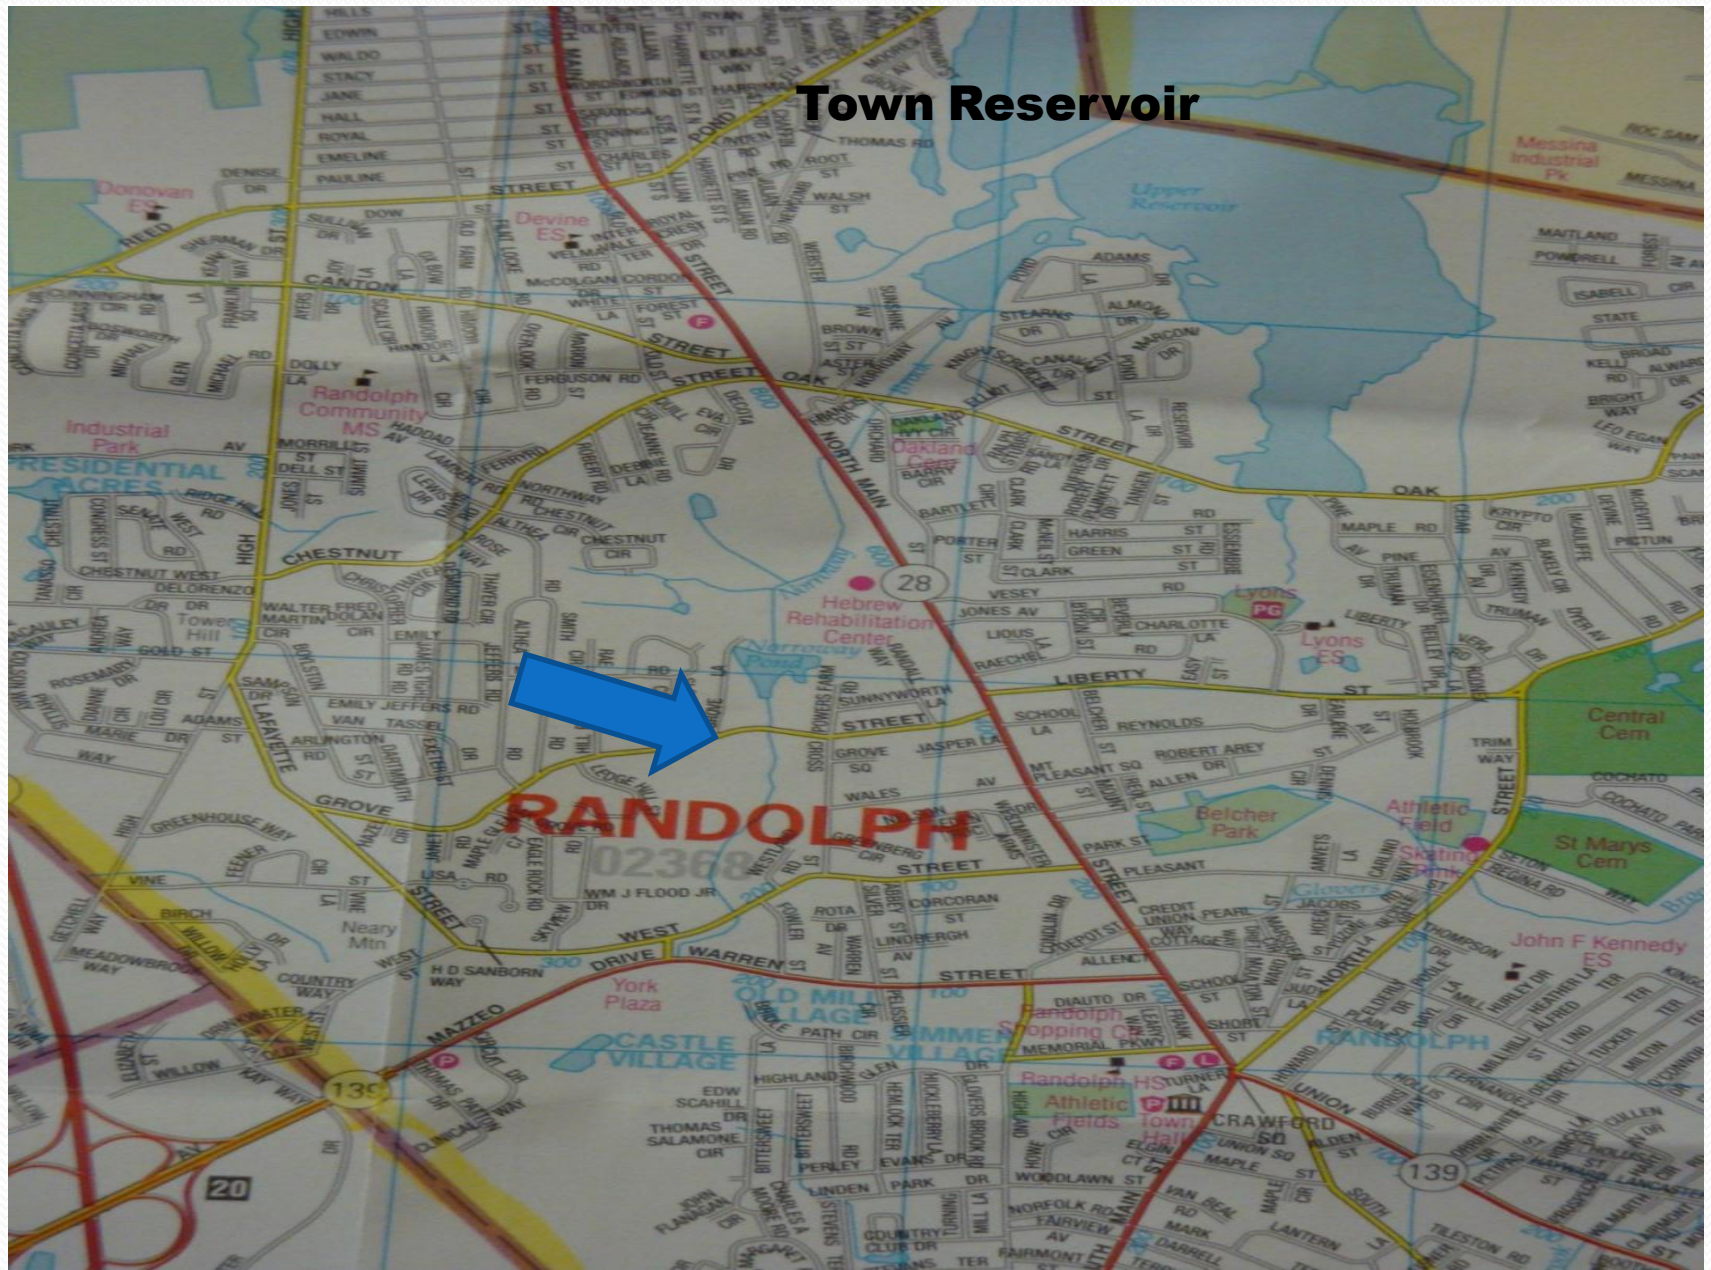
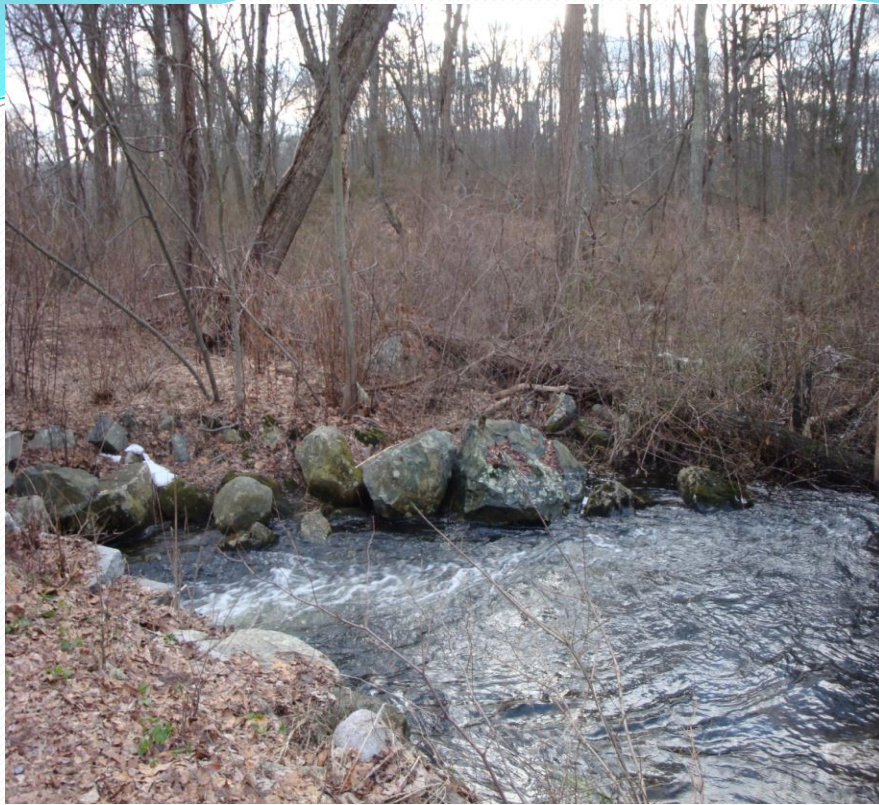
Where in the World is Grove Street?

This stream passes under
three streets; Warren St.(rt.
139, West St. &
Grove St., eventually
running into Norroway
Pond.

All three streets connect
to Main St. Rt. 139 is a
heavily traveled road
connecting Randolph with
Stoughton and Holbrook.

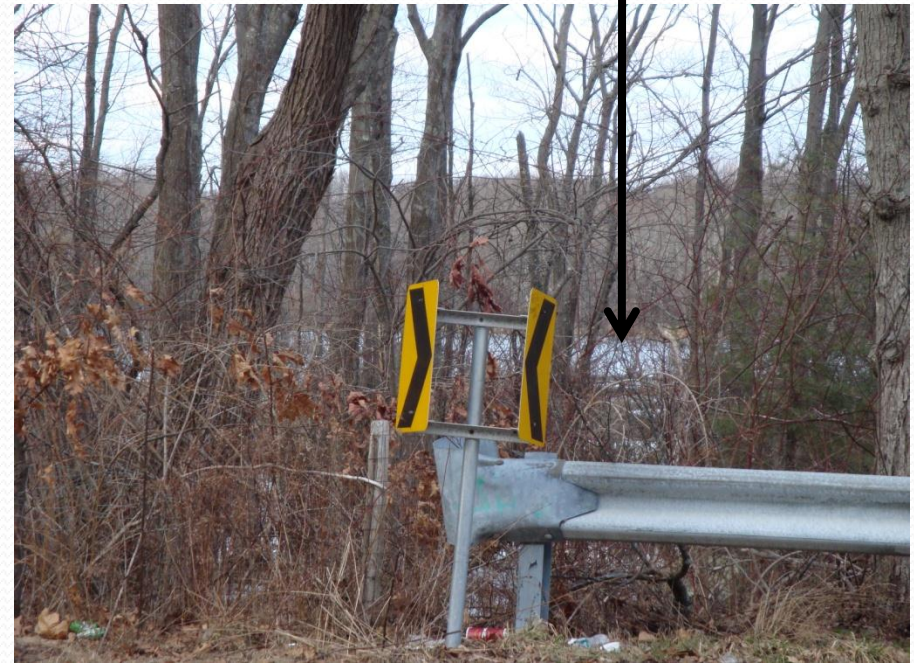
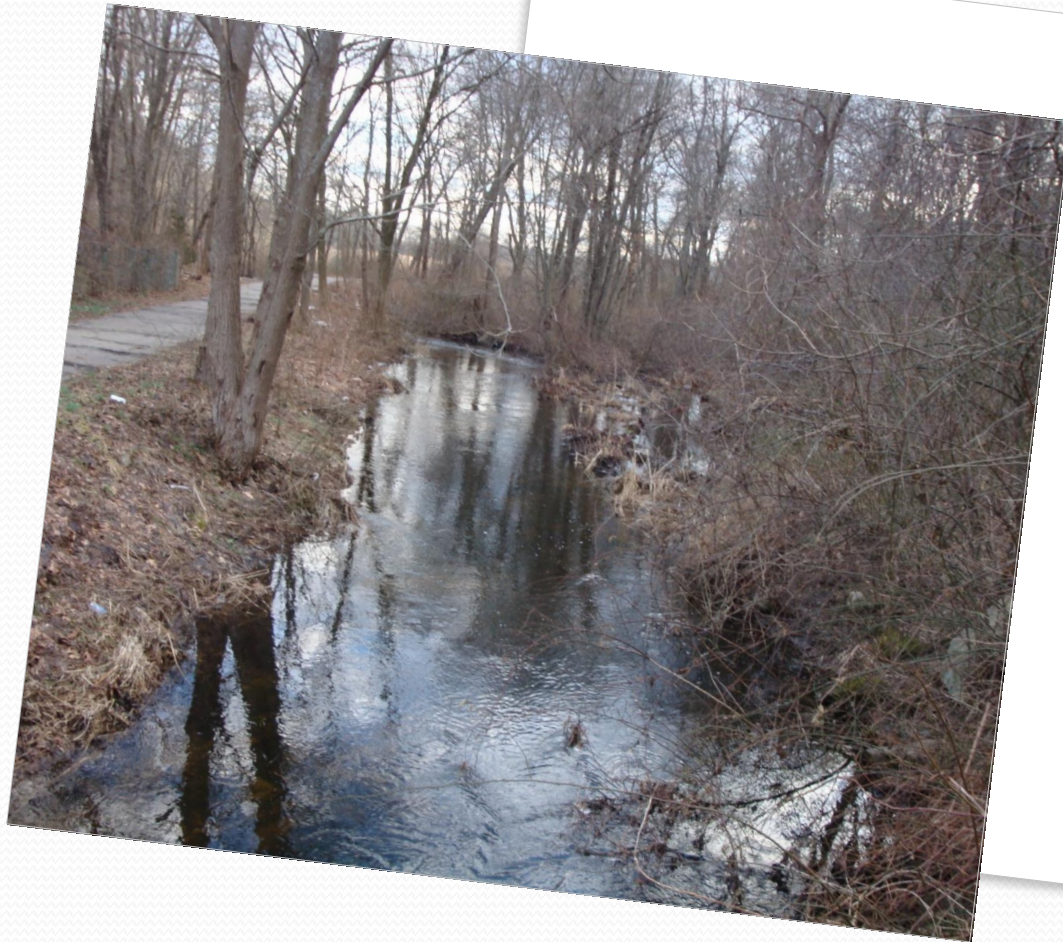
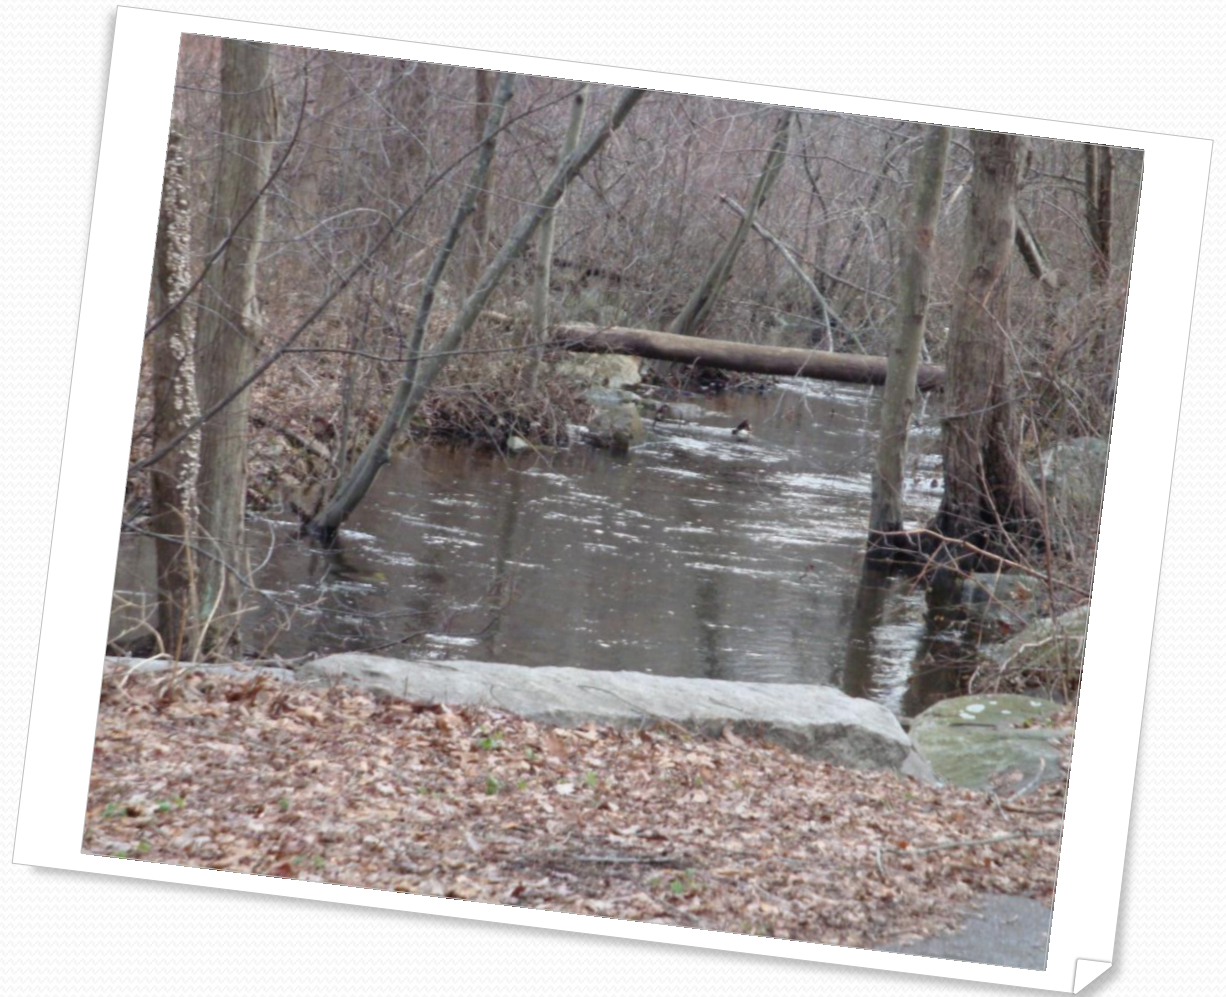
A walking trail
runs along the
stream
between West
and Grove St.

The walking trail
passes over the
stream at one
point.

The water
was
flowing
pretty
quickly the
day we
went out.

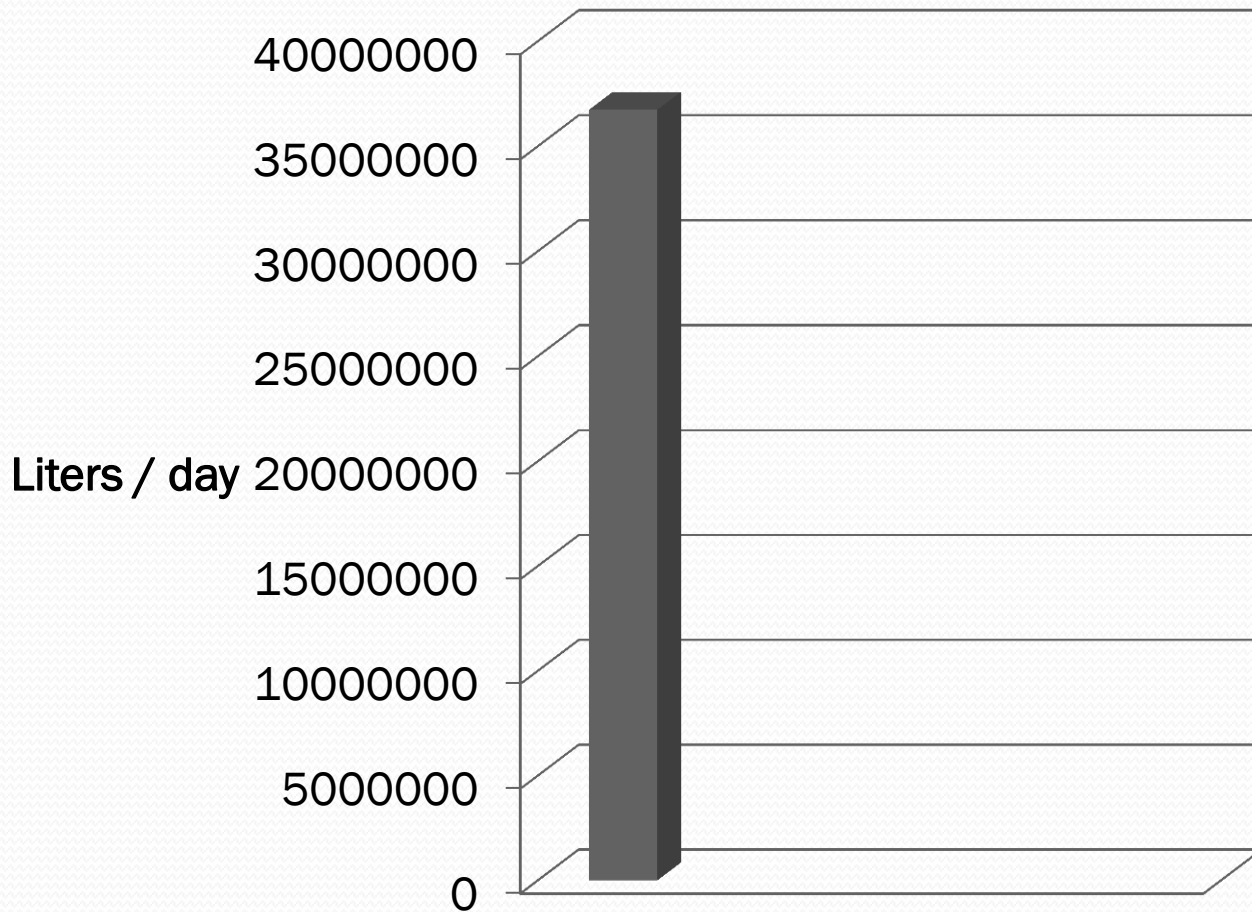
Water Discharge per Day

Discharge is found by multiplying the speed of the water by the volume of the water flowing down the stream.
